# Student Union Building – Sustainability Initiatives

project number:	F04567
submission title:	DRAFT 1
date:	16-11-2020

## **2. Introduction**

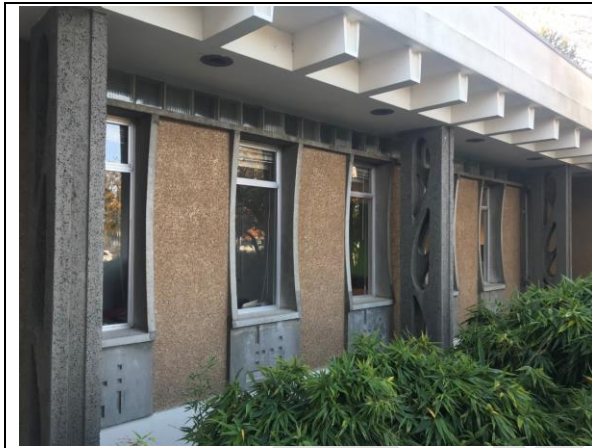
**Photo 6.1** – 1963 construction. Main floor - visible original single pane windows with glass blocks (transom window) above

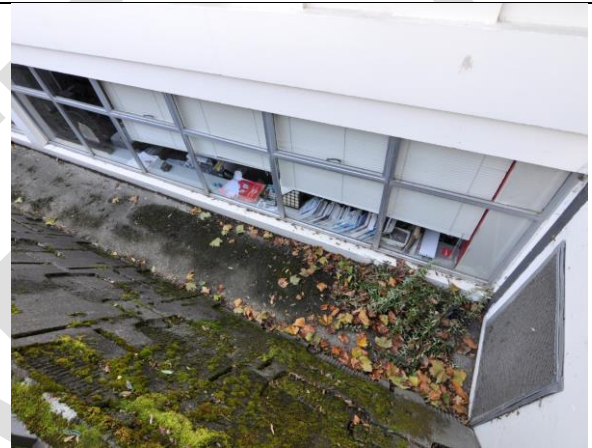
**Photo 6.2** – 1963 construction. Room B011 - visible original single pane windows

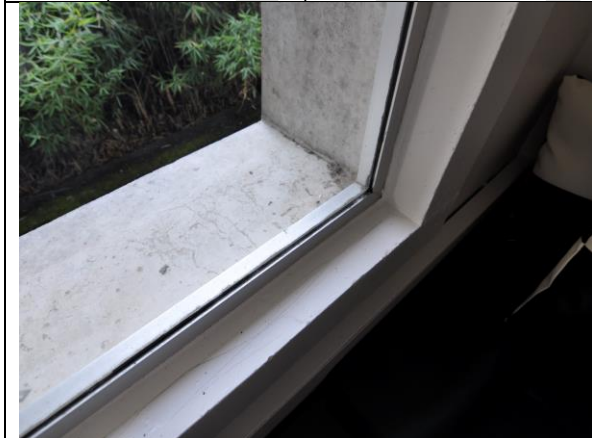
**Photo 6.3** – 1963 construction. Room B107 - visible original single pane windows in solid concrete jamb.

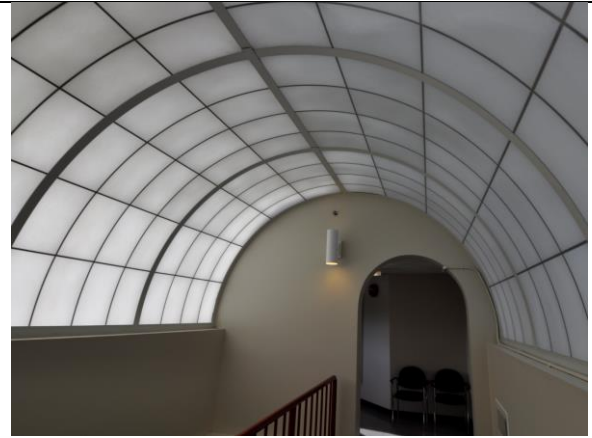
**Photo 6.4** – 1996 renovation. Corridor B201 – Kalwall skylight

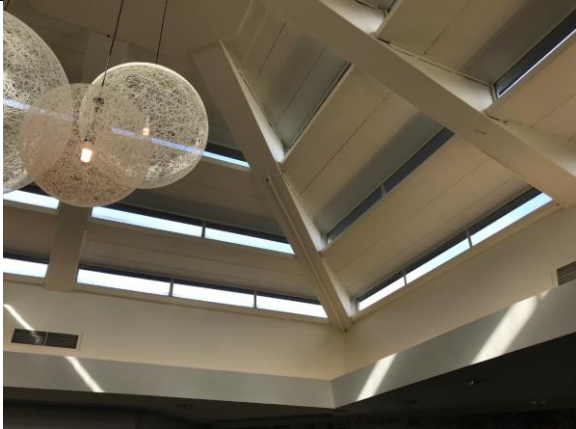
**Photo 6.5** – 1963 construction. Upper Lounge (Room B110) Visible original single pane transom windows.

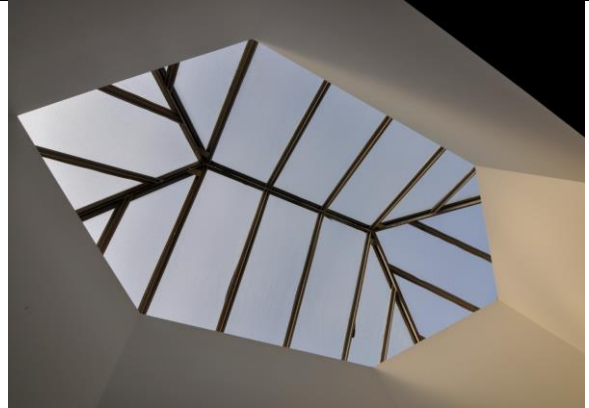
**Photo 6.6** – 1963, Room B103 – Student Services Centre - visible original single pane (wired glass) in metal frame skylight.

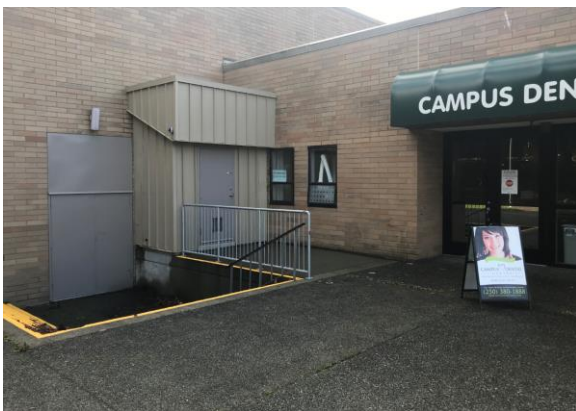
**Photo 6.7** – 1974 addition. Visible pressed steel metal door, double pane punched windows and single pane storefront

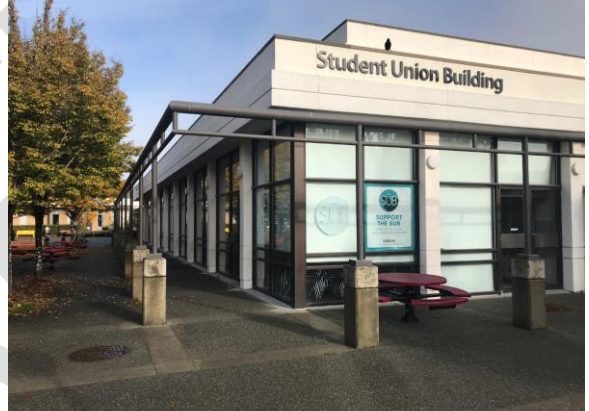
**Photo 6.8** – 1996 addition, Visible Kawneer storefront glazing with steel frame in front to accommodate exterior shading devices.

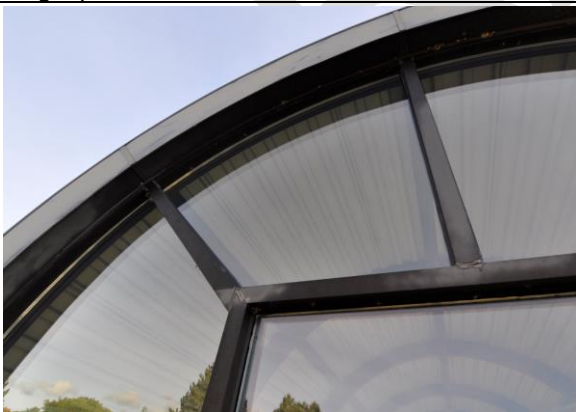
**Photo 6.9** –Kawneer system transom window

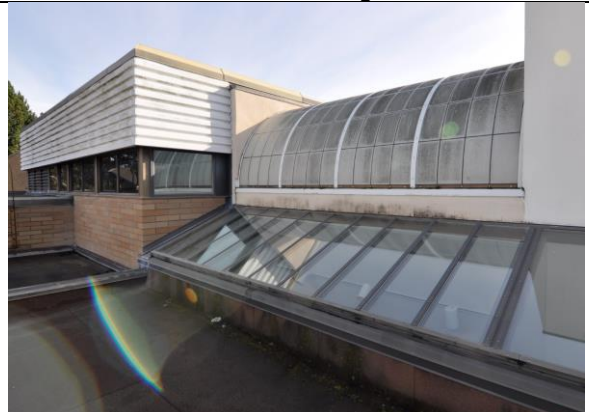
**Photo 6.10** – looking toward Phase 2 addition with Kalwall and Kawneer skylights in front.

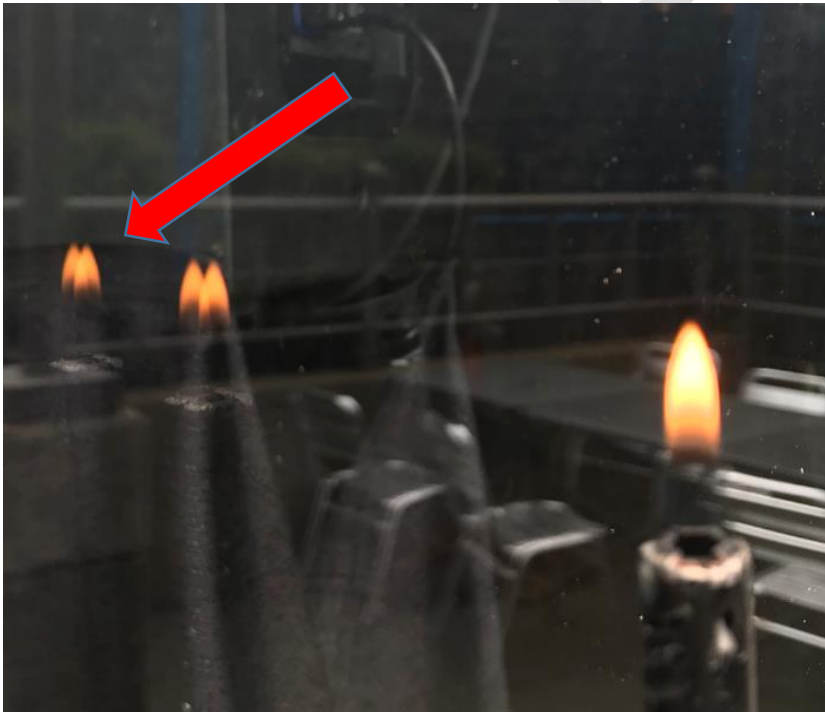
To confirm presence of Low-E coating (typically expected to be on the 3<sup>rd</sup> glass surface) Zeidler Architecture performed simple flame reflection test. As per this test, flame reflection from glass surface coated with Low-E, should be discoloured. As per conducted, at random locations, tests all flame reflections appear to be of the same colour indicating **NO PRESENCE** of Low-E coating. It should be noted however that the test was limited to few random locations at ground floor only and more tests should be conducted to confirm. See also photo 7.1 below.

As per provided to us information typically presence of Argon is a strong indicator of Low-E coating however this particular glazing systems may have been installed prior to introduction of Low-E coating (Argon infill was introduced earlier). Further investigation is strongly recommended.

**Photo 7.1**  
South facing window.  
Reflection on the 3<sup>rd</sup> surface (indicated by an arrow) of the same colour as the other surface indicating no Low-E coating. This contributes to overheating of the rooms.

1. Phase 1 and phase 2 building area:
  - Replace single pane, non-thermally broken window, door and skylight assemblies with code complaint Insulated Glazing Units (IGU) systems. On the south elevation, the new IGU's should have lower SHGC to reduce heat gain from the sunlight. Size and configuration of units to remain however preference is to have more operable units to provide more natural ventilation.
  - Install thermal insulation on interior face of solid concrete window jambs to reduce thermal bridging.
  - Install vestibules at main entrances to reduce loss/gain of heat.
2. Phase 3 building area:
  - Replace single pane glazing in doors with IGU's. On south and west elevation / in areas with high heat gain retrofit existing storefront system with IGU's with COG = 0.24 or lower and with low(er)SHGC to help reduce heat gain from sunlight.

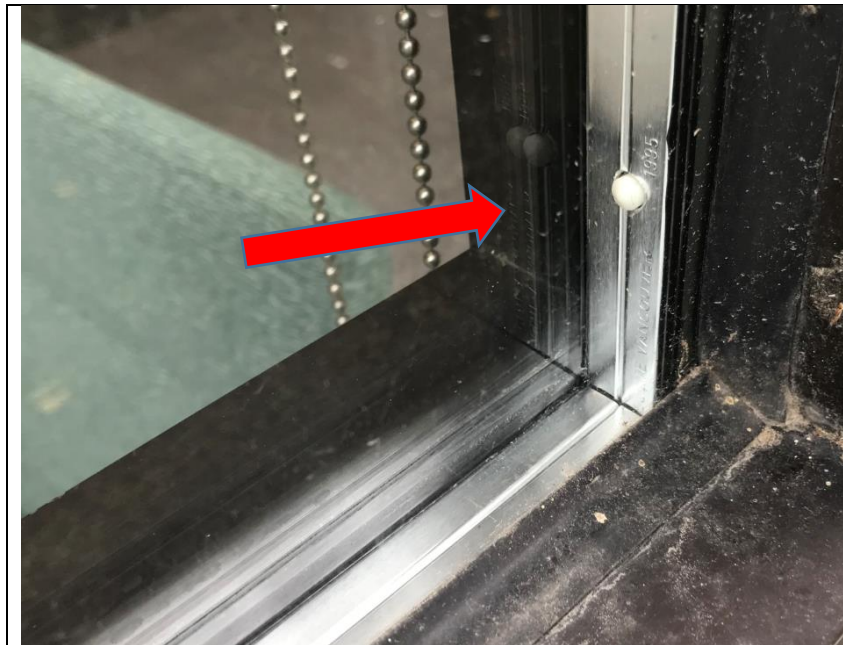
We also reviewed most of the, accessible from ground level, Kawneer system IGU's for presence of Argon. Test was limited to confirmation of presence of gas insert holes in spacers. As per our observations, most of the IGU's are Argon filled. Similarly, as above the test was limited to few random locations at ground

Photo 7.2  
 Plugs in glazing spacer  
 indicate presence of Argon in  
 the IGU's

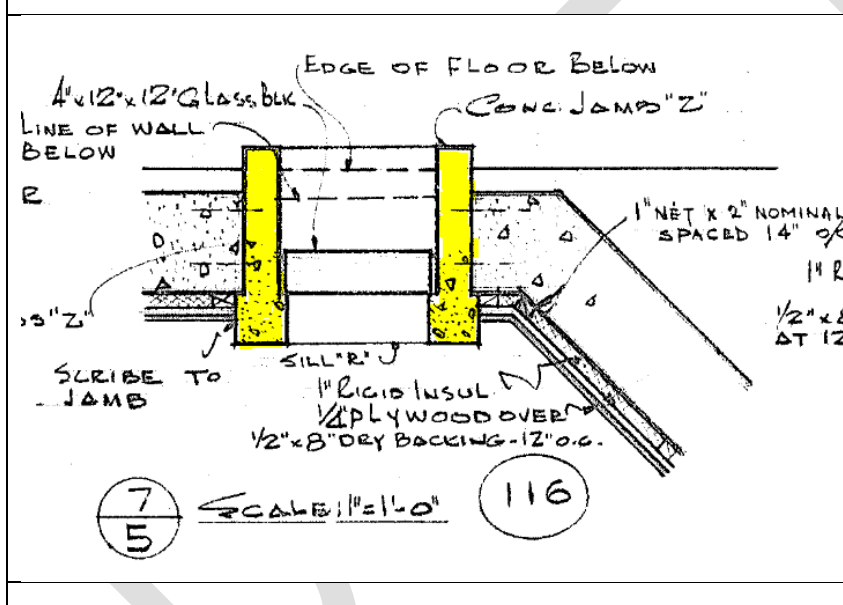
1. Phase 1 – most windows are set in the original concrete jambs. These jambs are an attractive architectural feature however are monolithic concrete elements approx. 100mm wide and 400mm deep and are contributing to thermal discomfort in the rooms. This is largely due to heat loss through thermal bridging effect.  
See also photo 7.3 and 7.4 below.
2. As per review of the existing drawings the exterior tubular steel structure on south and west side of the building was originally designed to provide support to an exterior awning/shading device (see Photo 7.5) It was noted, however that the structure is not being used as intended allowing the strong south /east sun to penetrate the building interior (see Photo 6.8). This in combination with low(er) performing glazing (no Low-E coating) appears to be contributing to overheating in number of rooms.

Photo 7.3 – phase 1 existing  
 concrete window jambs

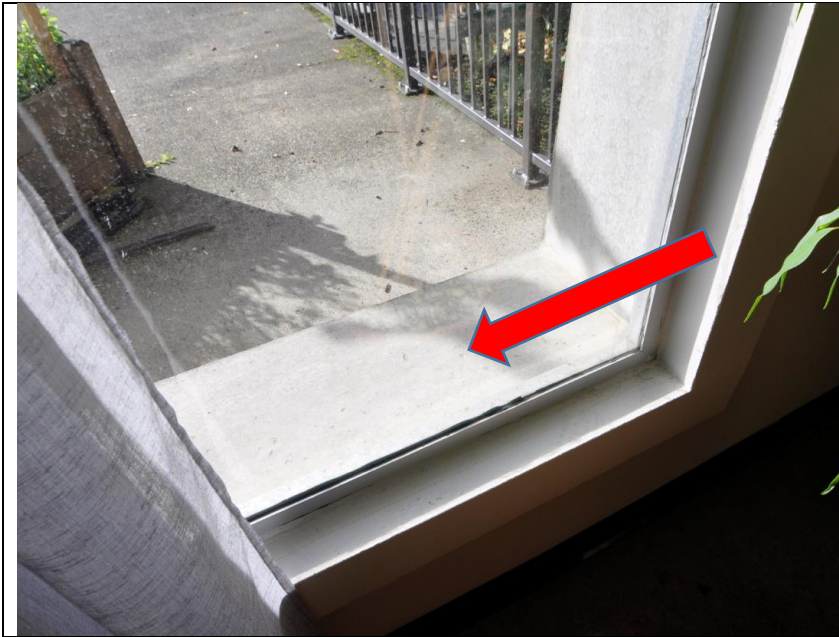
Photo 7.4 – phase 1 existing concrete window jambs
